Home Survey Report Sample

Dave Grandstaff
Southeast Home Inspections
1225 Pisgah Church Rd
Aynor, SC 29511
843-358-2241

Address of the Property Inspected

246 North Elm
Smolderville, SC 29567
214-123-45676

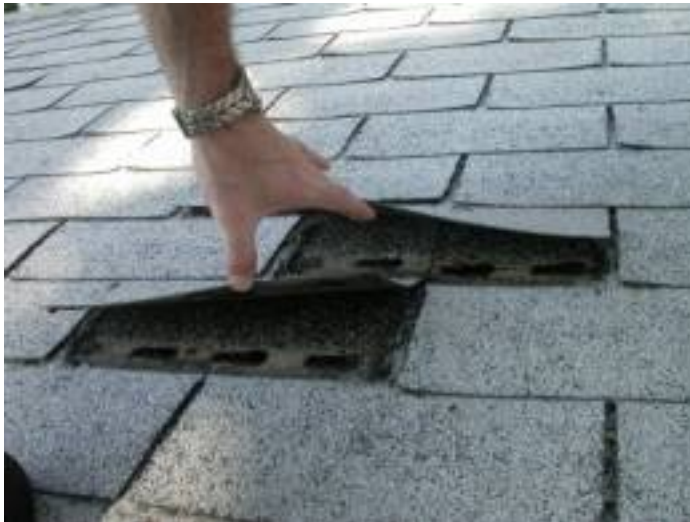
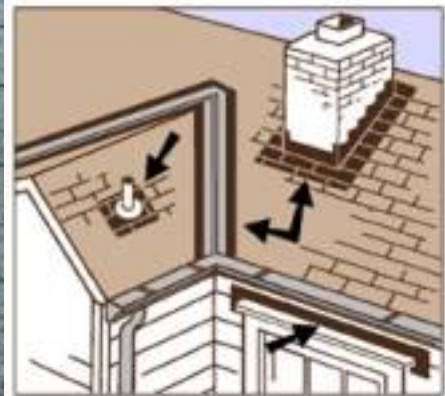
[3C.01](#) Shingles, asphalt: broken loose right front side above main entrance.

[3A.20](#) Roof (not roof structure) comparative rating: apparently fair

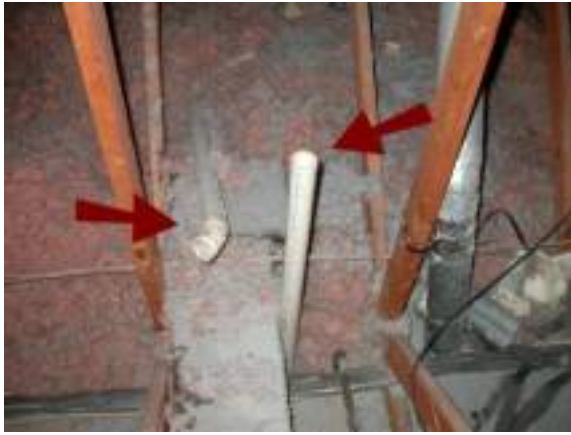
[4C.21](#) Broken plumbing vent pipe within attic.

ABS pipe, perhaps manufactured between 1985 and 1989—the following brand name was found that is subject of a lawsuit (pipes could fail): Centaur. This is an expense concern. Evaluation by a specialist is recommended

[4C.21](#) ABS pipe, perhaps manufactured between 1985 and 1989—the following brand name was found that is subject of a lawsuit (pipes could fail): Centaur.

This is an expense concern. Evaluation by a specialist is recommended

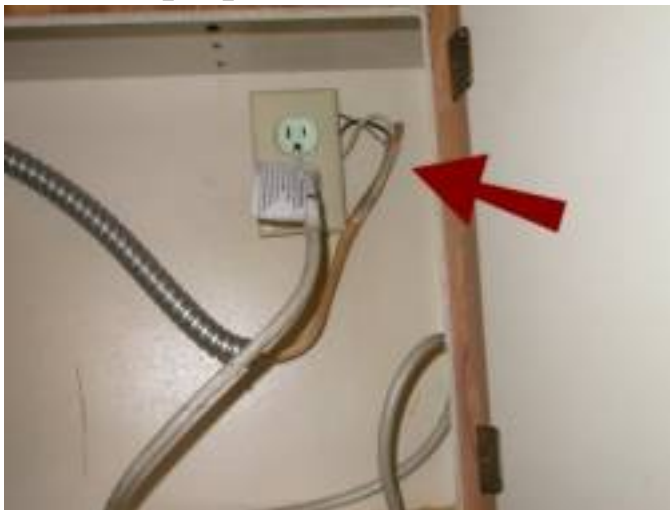
[5A.14](#) **Improper cable connection at receptacle outlet in basement**

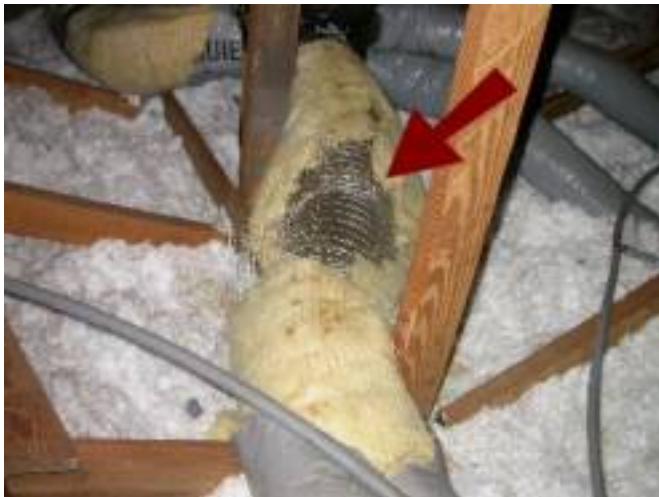
[6C.05](#) Flex duct deterioration of outer wrap in the attic, missing duct outer covering

(vapor barrier) and insulation

[6C.05](#) Flex duct deterioration of outer wrap in the attic

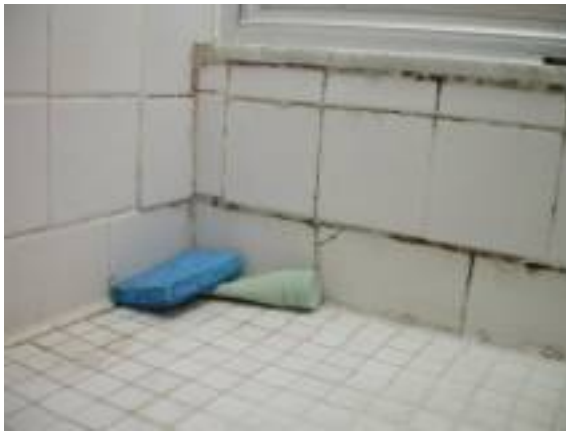
[8C.01](#) Shower: stains on ceiling below in the living room indicates leak?

Moisture meter indicates no moisture is present in stains, deteriorated and cracked tile grouting in shower in master bath room.

8C.01 Shower: stains on ceiling below in the living room indicates leak?

Moisture meter indicates no moisture is present in stains
